Case 268 : Narrative

Case Vehicle (A): 1999 Chevrolet
Type: Cavalier, 2-door coupe
Driver: 37-year-old male
CDC: 12-FRWN-3, 12-RFES-1, 12-FLWN-3

GENERAL VEHICLE DAMAGE AND ESTIMATED CRASH SEVERITIES

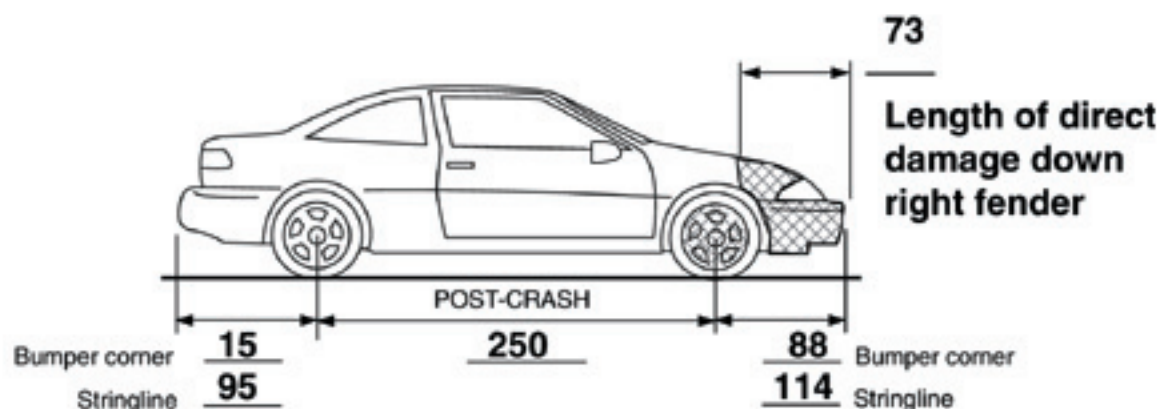
Max. crush to
right front fender

5 Damage to case vehicle (A) was minor. 6 7 Direct damage from the pole impact began at the right-front bumper corner and extended 73-cm rearward to the middle of the right fender. The maximum crush was 10 cm and occurred just forward of the right-front wheel. Direct damage from the initial wheel impact with the curb and/or planter box involved the right-front tire and wheel. 8 The rim was not deformed, but the wheelbase was reduced by 14 cm and the tire was flat.

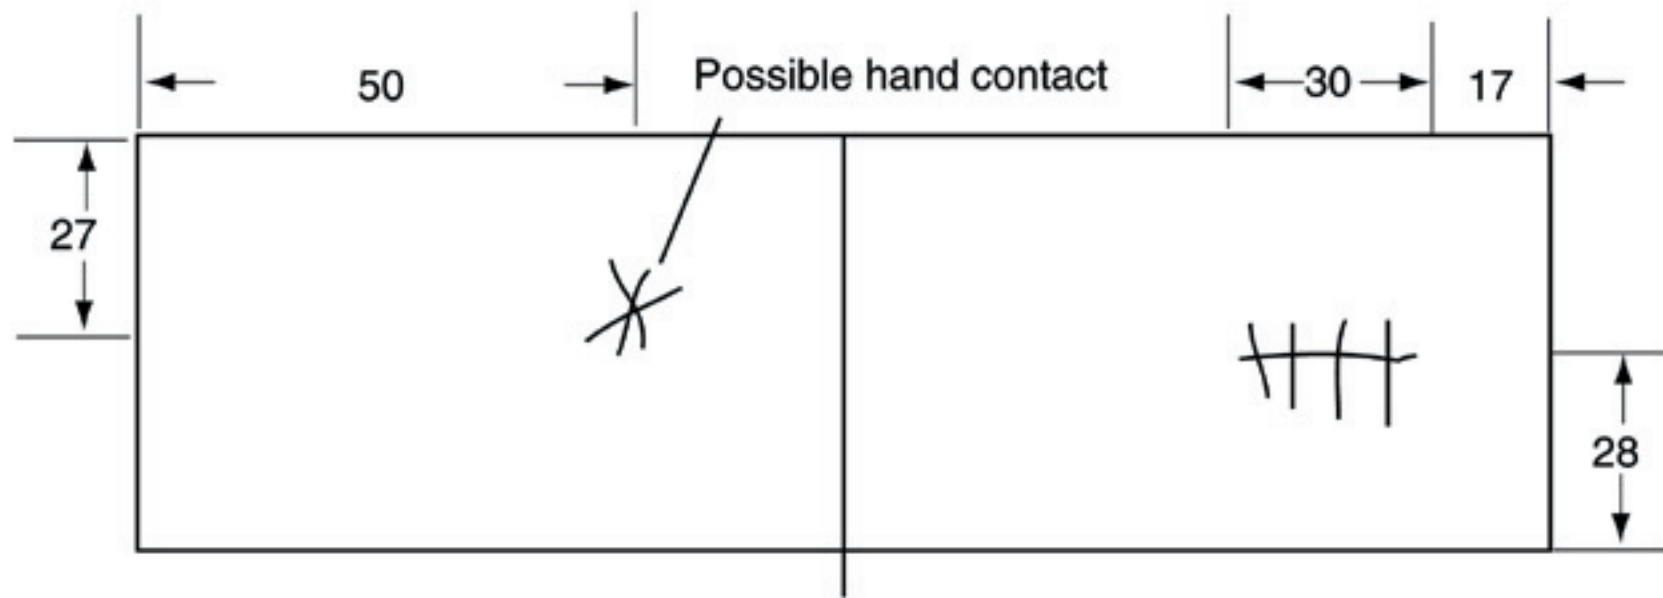
cracked due to contact by passenger airbag module cover

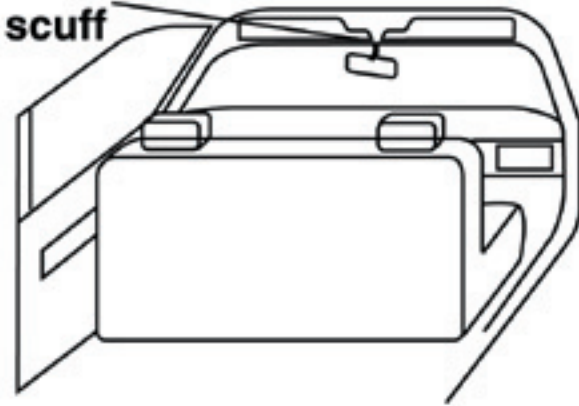
**A = sunvisor,
possible scuff
mark**

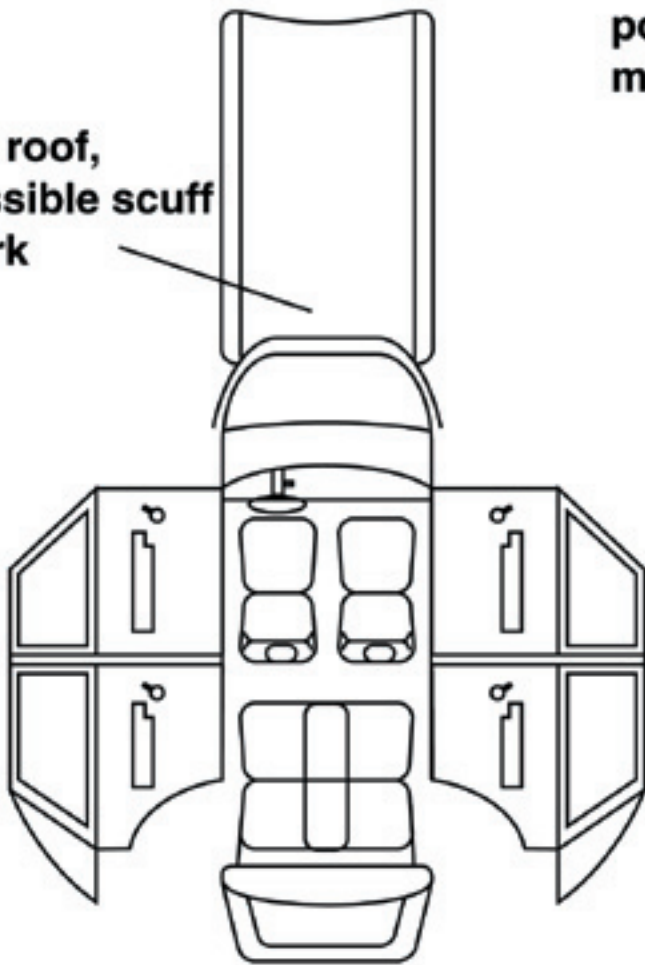
**B = roof,
possible scuff
mark**

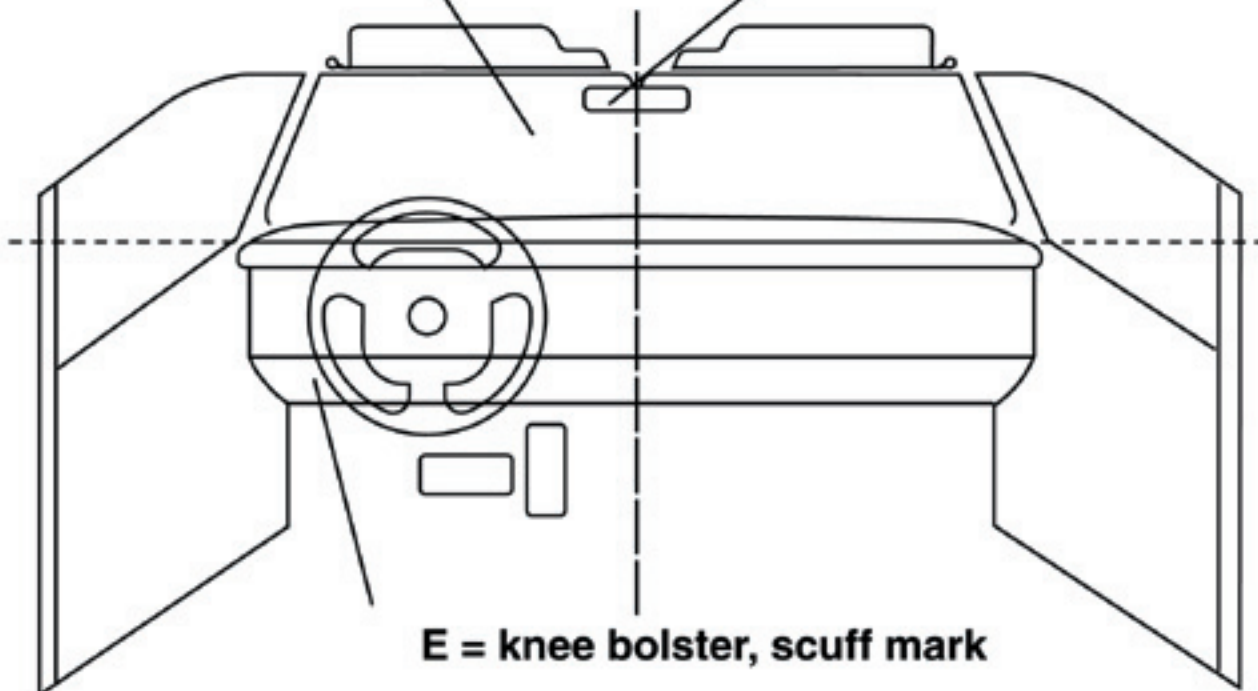
**C = windshield,
possible scuff
mark**

**D = rearview mirror,
smudge mark (possibly
oil from skin)**
